Navy Experimental Diving Unit  
321 Bullfinch Rd.  
Panama City, FL 32407-7015

TA 09-04  
NEDU TR 11-08  
May 2011

## **FIELD EVALUATION OF TOPSIDE DECOMPRESSION MONITOR (TDM) DURING SHIPS HUSBANDRY DIVING AT SWRMC-NI**

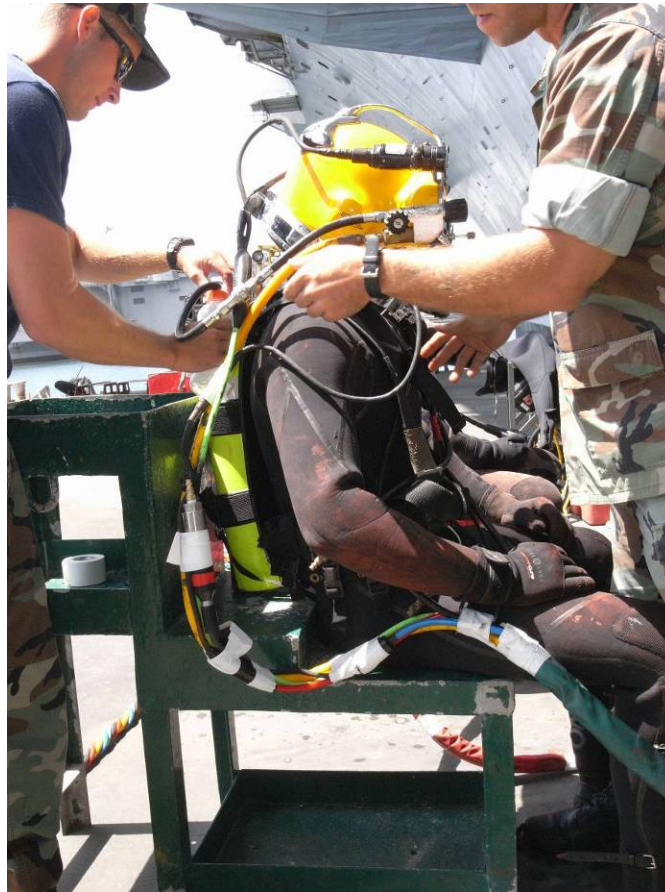
To avoid interfering with normal diving operations, the pressure transducer for each diver was attached to the existing surface-supplied umbilical between the shackle and the helmet behind the diver (Figure 1).

**Figure 1.** Sensor placement on diver's umbilical.

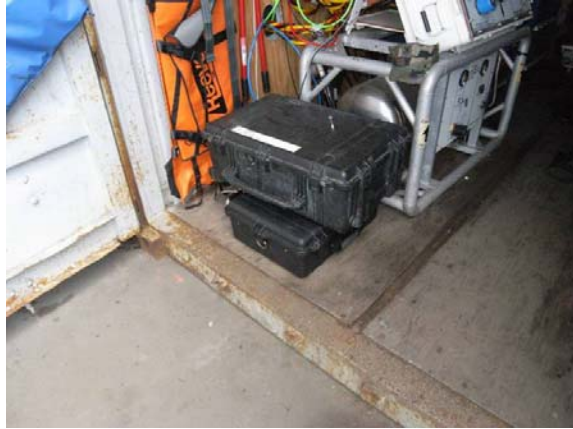
**Figure 2.** Sensor interface box placed inside van and next to FADS console.

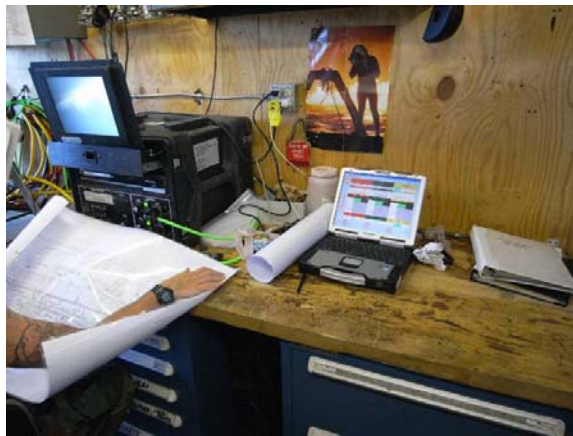
**Figure 3.** TDM laptop on desk next to communications console, to allow it to be operated in conjunction with communications.

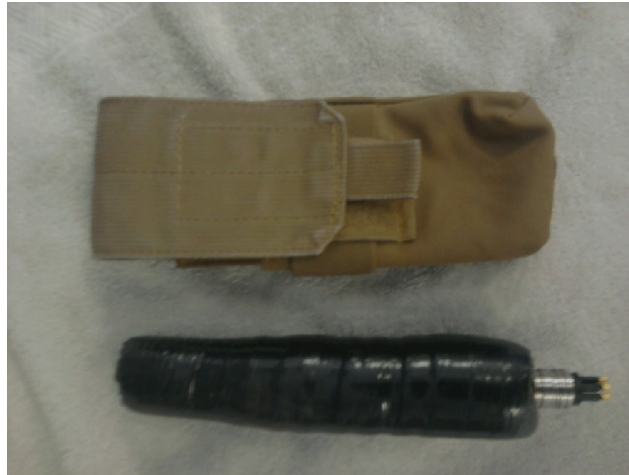
Still another problem associated with using the TDM during ships husbandry will be that of the sensor port becoming clogged with mud or silt from the bottom — or with the Bintsuke that is used to seal cofferdams to ships' shafts. Bintsuke, a sticky substance used to plug holes and keep water from entering between the patch and the vessel, must be kept away from the sensors: Clearing a clogged sensor underwater is already difficult, due to its position and the small size of the opening. M16 double magazine pouches were purchased from a surplus store and modified to make pouches to protect sensors. A hole was cut in the bottom of the pouch to allow entry of the sensor cable, and the Velcro closures at the top of the pouch made the sensor accessible for verification or cleaning. Foam padding ( $\frac{1}{4}$ -inch plumbing insulation) was added to the sensors to reduce damage from impacts (Figure 4).

**Figure 4.** Foam-protected sensor and M16 double magazine pouch.

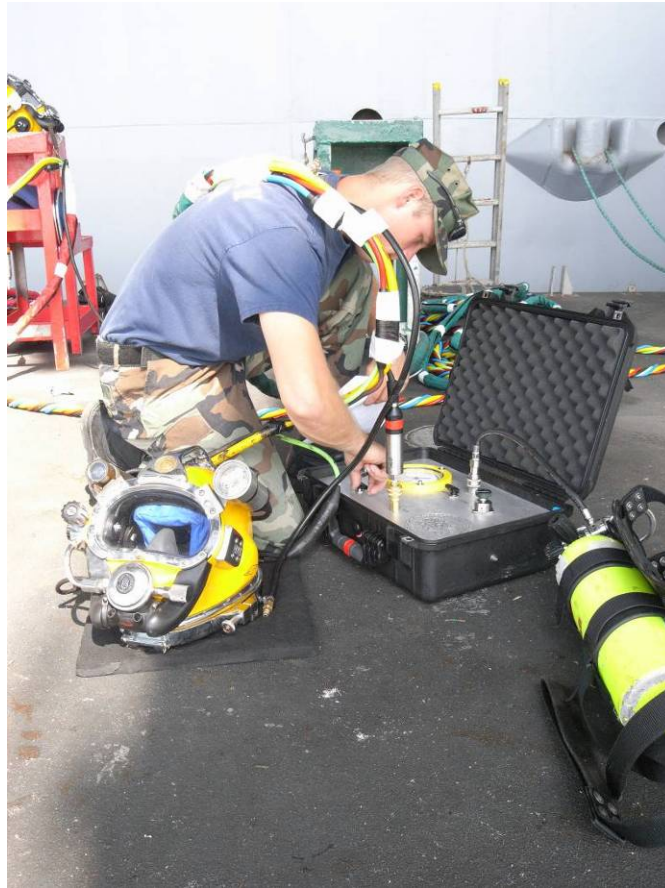
window, accessible through the TDM's configuration screen, was used to match sensor readings to supplied pressures at 6 pressures. One downside to the initial configuration of the SVB was that the sensor needed to be oriented vertically above the SVB in order to perform the verification (Figure 5). The process of verifying a sensor while it remained attached to the diver's umbilical placed unnecessary stress on the flexible whip ends that had already been identified as weak points. A 10 ft adapter cable with a three-way split allowing simultaneous connection of all three sensors reduced the stress on the cable as well as the overhead on the dive side.

**Figure 5.** Diver setting up sensor verification. Care was needed to avoid excessive stress on the cable during verification.
